Manhole Inspection Summary

Manhole # S39AA1003MH

Location Address: **725 34TH ST**

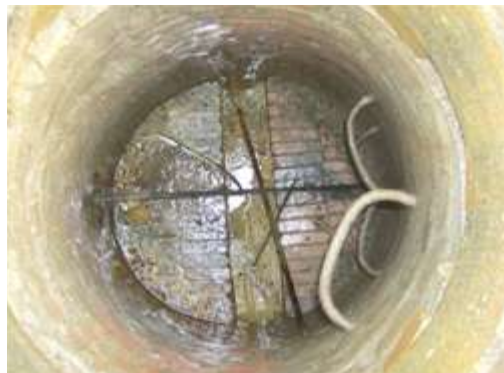
Top View

Bench and Channel debris.

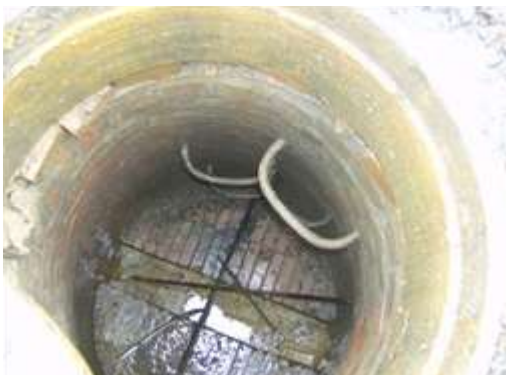
Defect

Frame leaks. Frame offset. Adjustment deterioration, loose brick and infiltration.

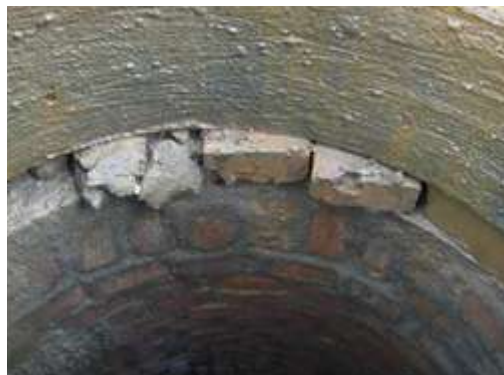
Defect

Frame leaks. Adjustment deterioration, loose brick and infiltration.

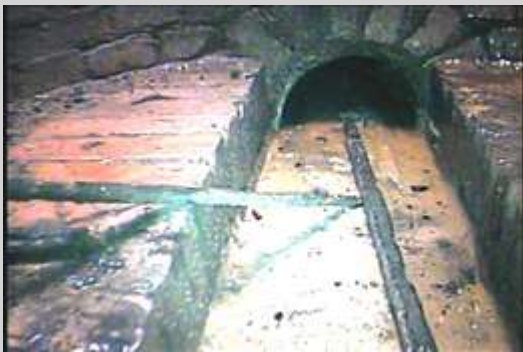
8 in. Circular Gravity Sewer Pipe Out @ 12 O'Clock

Deposits: ☐ None ☒ **Mud** ☐ Sludge ☒ **Debris** ☐ Grease

Silt Depth: **3** (in.) Deposits Extent: **Medium**

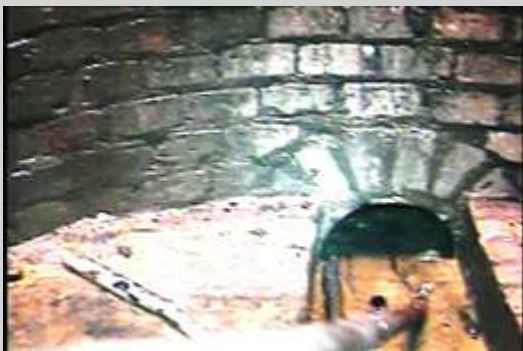
8 in. Circular Gravity Sewer Pipe In @ 6 O'Clock

Barrel deterioration and infiltration.

Deposits: ☐ None ☒ **Mud** ☐ Sludge ☒ **Debris** ☐ Grease

Silt Depth: **4** (in.) Deposits Extent: **Medium**
